**BARTILLA BOOSTER PUMP STATION REPAIR**  
COMMANDER'S EMERGENCY RESPONSE PROGRAM  
**NINEWA GOVERNORATE, IRAQ**

**SUSTAINMENT ASSESSMENT**

**SIGIR PA-07-109**  
**OCTOBER 23, 2007**

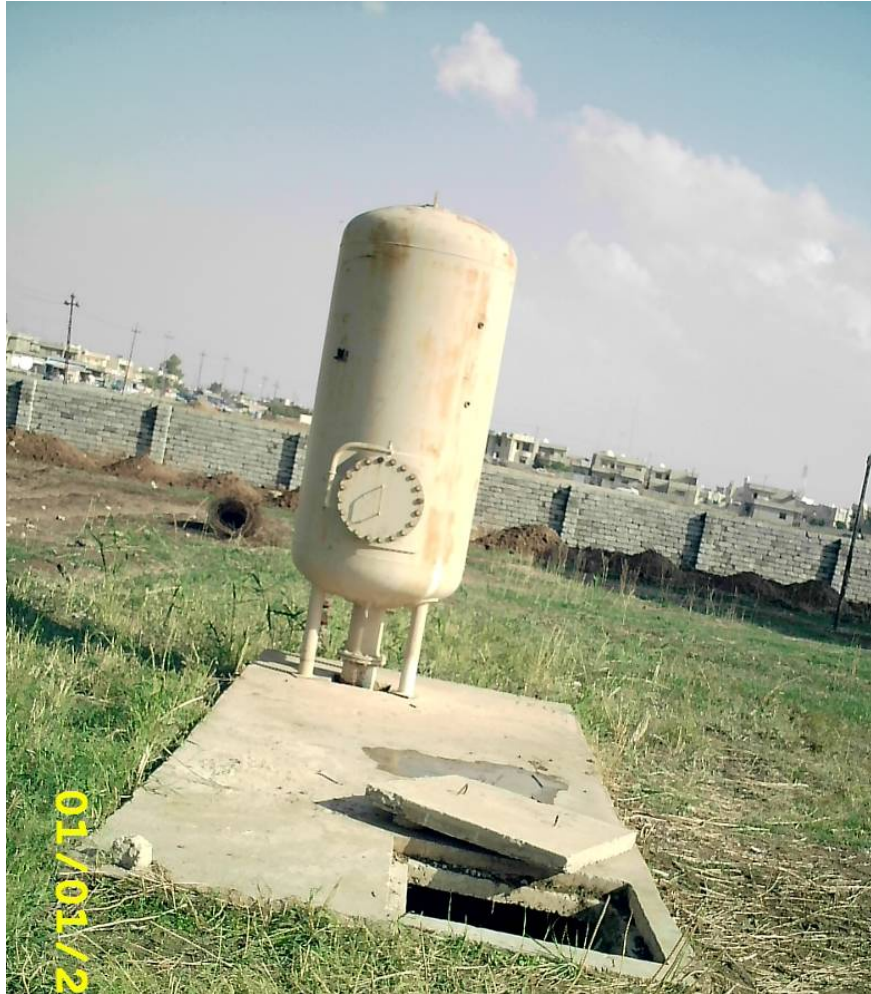
Site Photo 1 documents the anti-hummer system before any maintenance occurred, and Site Photo 2 shows the maintenance performed by the contractor on the anti-hummer system.

**Site Photo 1. Anti-Hummer system before maintenance (Photo courtesy of USACE)**

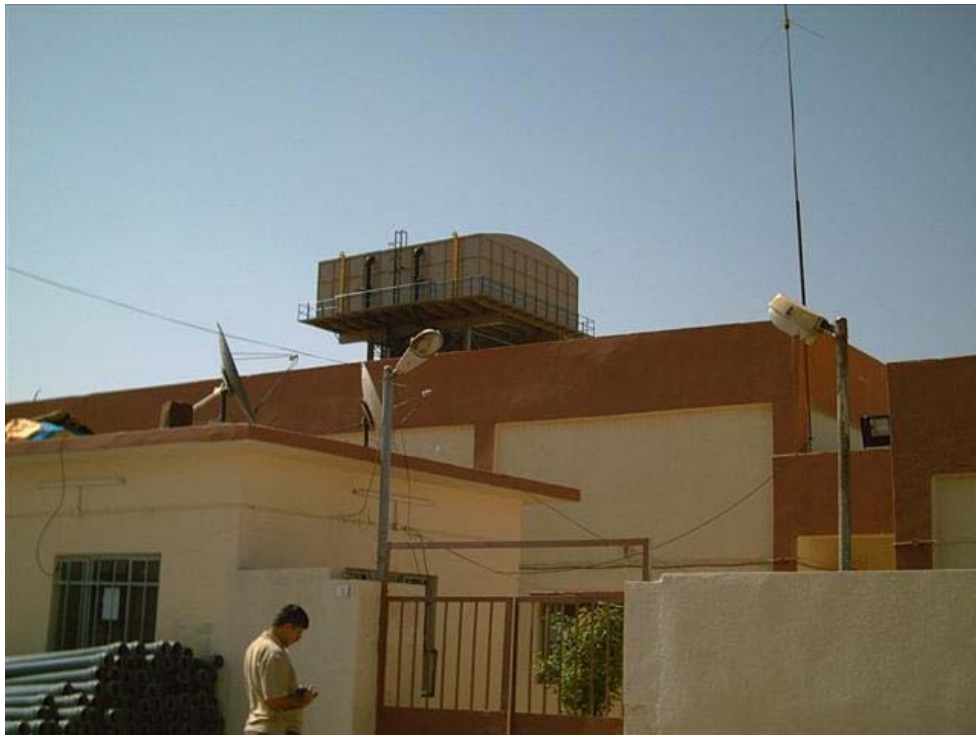
Site Photo 3 documents the general maintenance performed inside the booster pump station building and Site Photo 4 displays the general maintenance performed on the exterior of the booster pump station building, including the roof, walls, windows, doors, and exterior painting.

**Site Photo 4. General maintenance performed on the exterior of the Bartilla Booster Pump Station (Photo courtesy of USACE)**

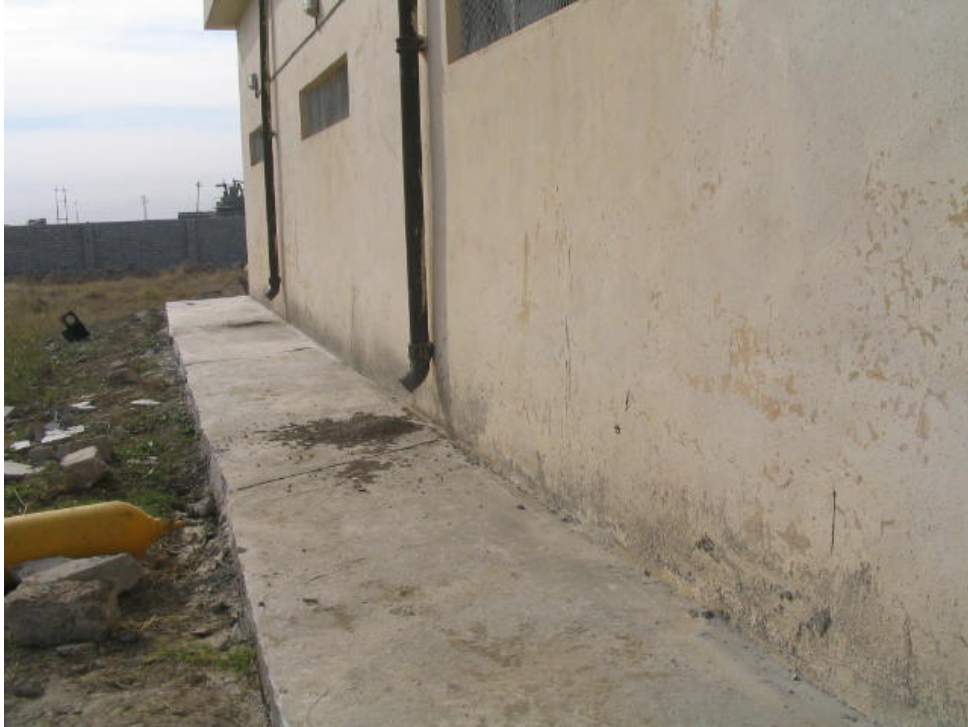
Site Photo 5 shows the recast walkway which replaced the old walkway that was demolished.

**Site Photo 5. New recast walkway (Photo courtesy of USACE)**

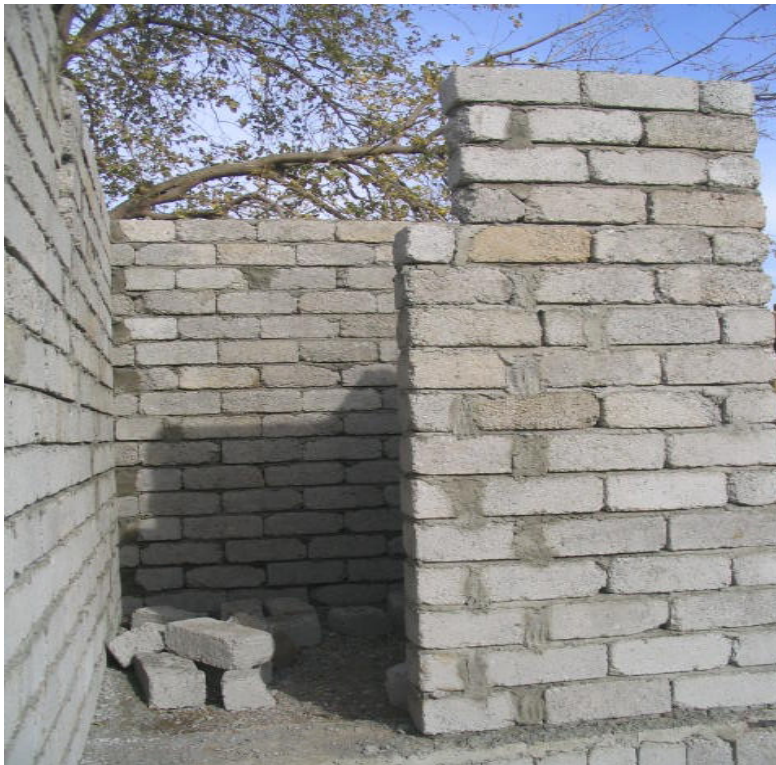
Site Photo 6 displays the new construction of a water closet at the Bartilla Booster Pump Station, and Site Photo 7 documents the completed construction of the water closet.

**Site Photo 6. Construction of a water closet (Photo courtesy of USACE)**

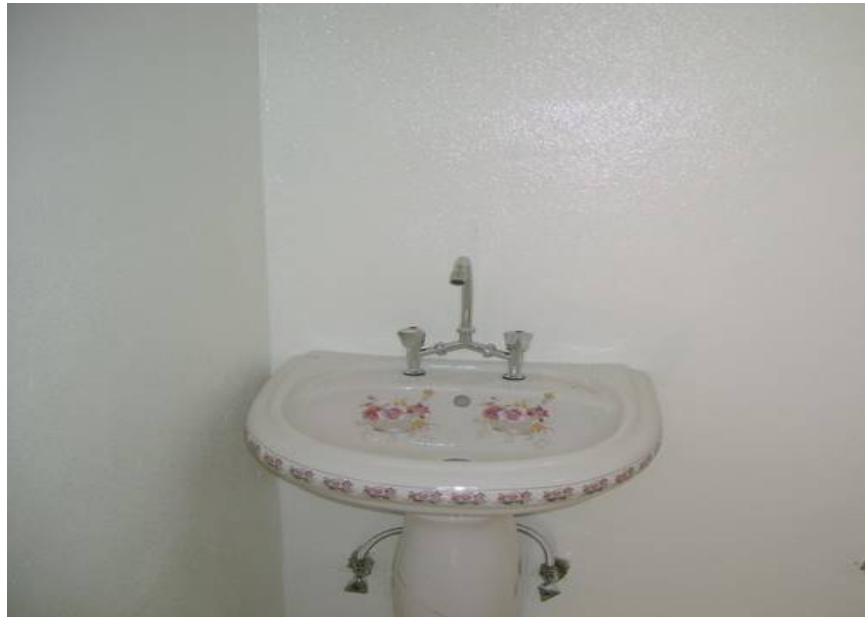
**Site Photo 7. Completed construction of water closet (Photo courtesy of USACE)**

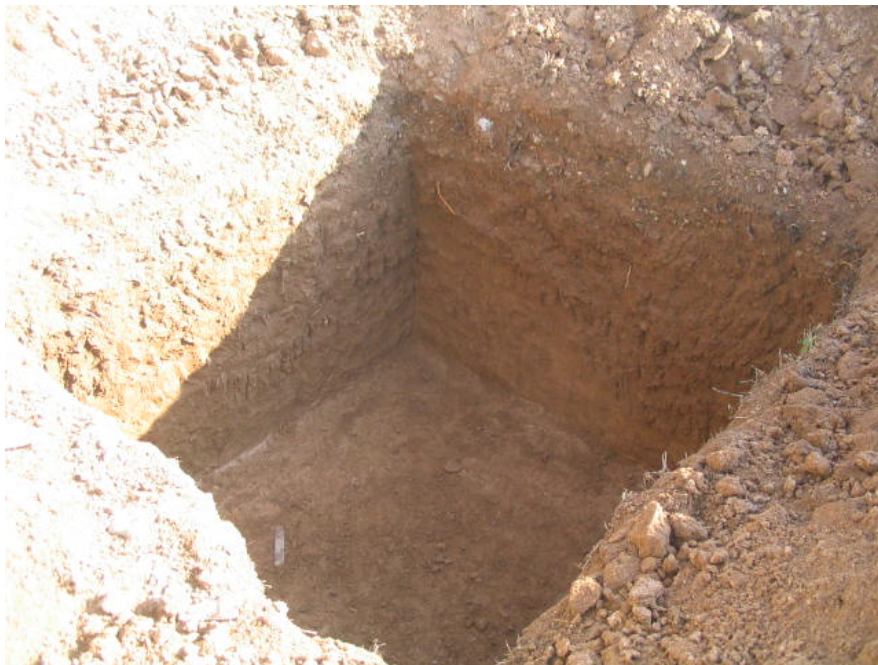
The excavation of the septic tank is shown in Site Photo 8, and Site Photo 9 documents the testing of the 2mx2mx2m septic tank.

**Site Photo 8. Excavation of septic tank (Photo courtesy of USACE)**

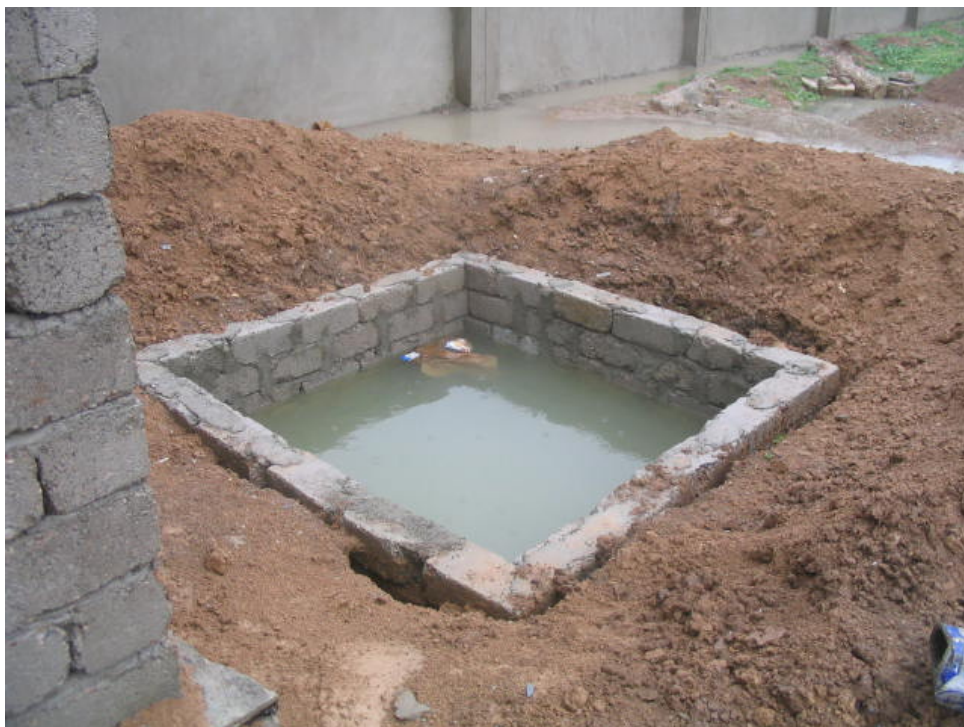
**Site Photo 9. Septic tank testing (Photo courtesy of USACE)**

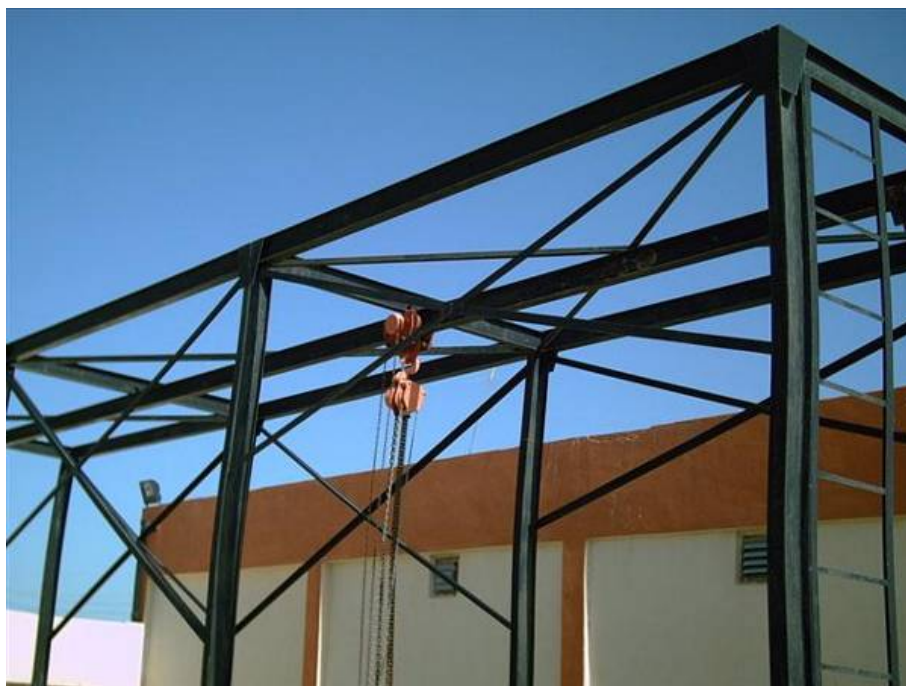
Site Photo 10 shows the installation of the hand-operated 3-ton crane for the ground storage tank.

**Site Photo 10. Installation of the new 3-ton crane (Photo courtesy of USACE)**

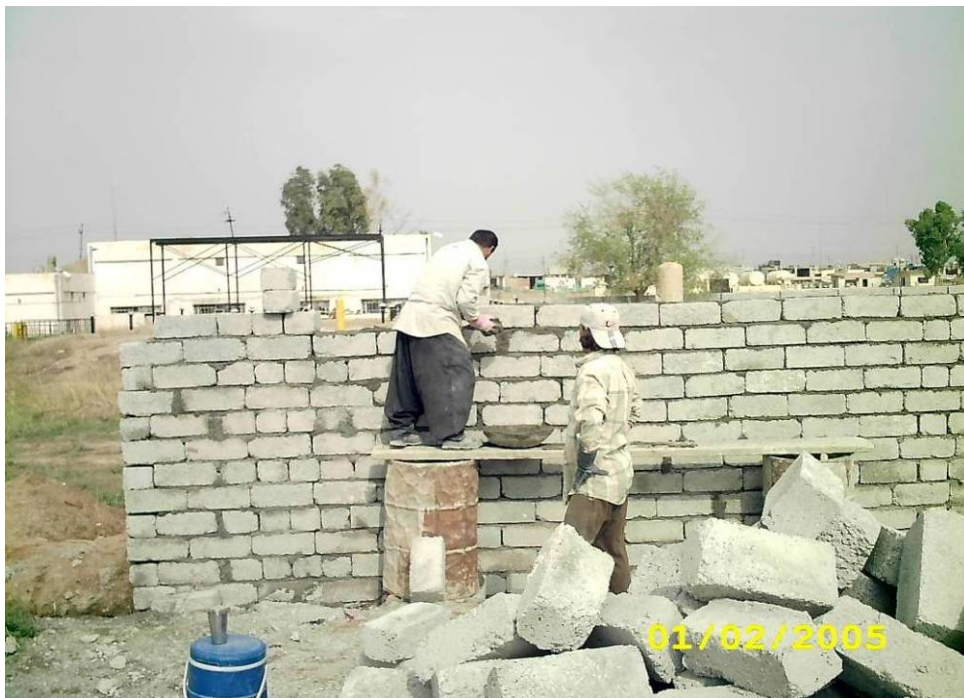
The construction of the two-meter high fence, made from concrete blocks and cement plaster, is shown in Site Photo 12. Site Photo 13 documents the completed construction of the two-meter high fence around the perimeter of the Bartilla Booster Pump Station.

**Site Photo 12. Construction of security wall (Photo courtesy of USACE)**

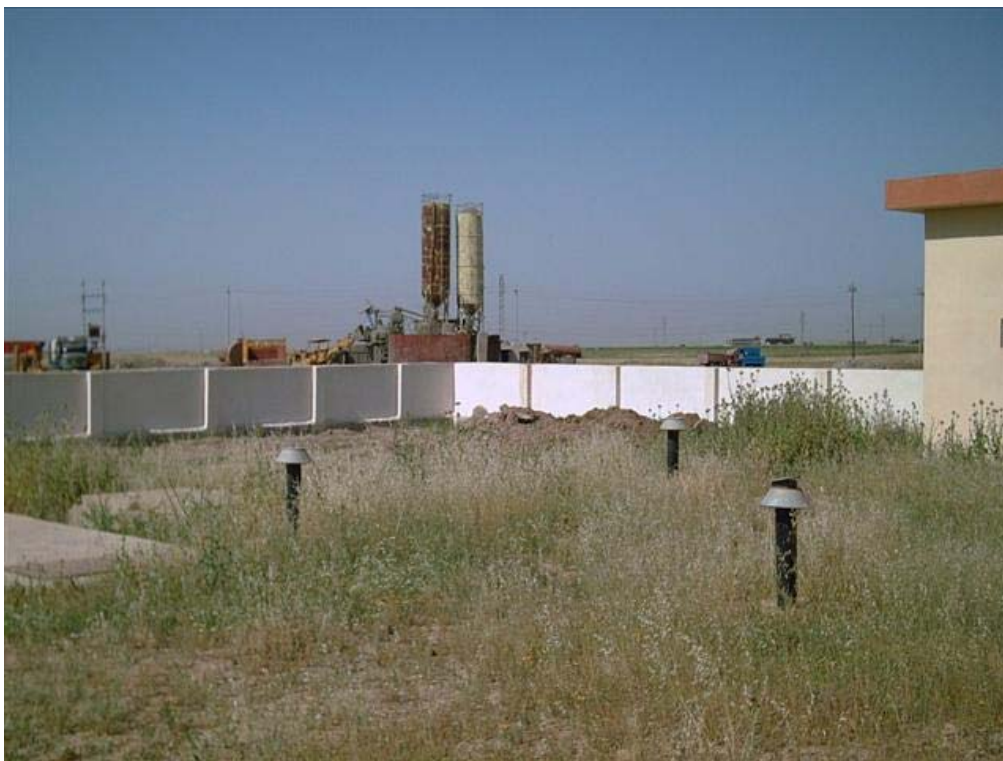
**Site Photo 13. Newly constructed security wall (Photo courtesy of USACE)**

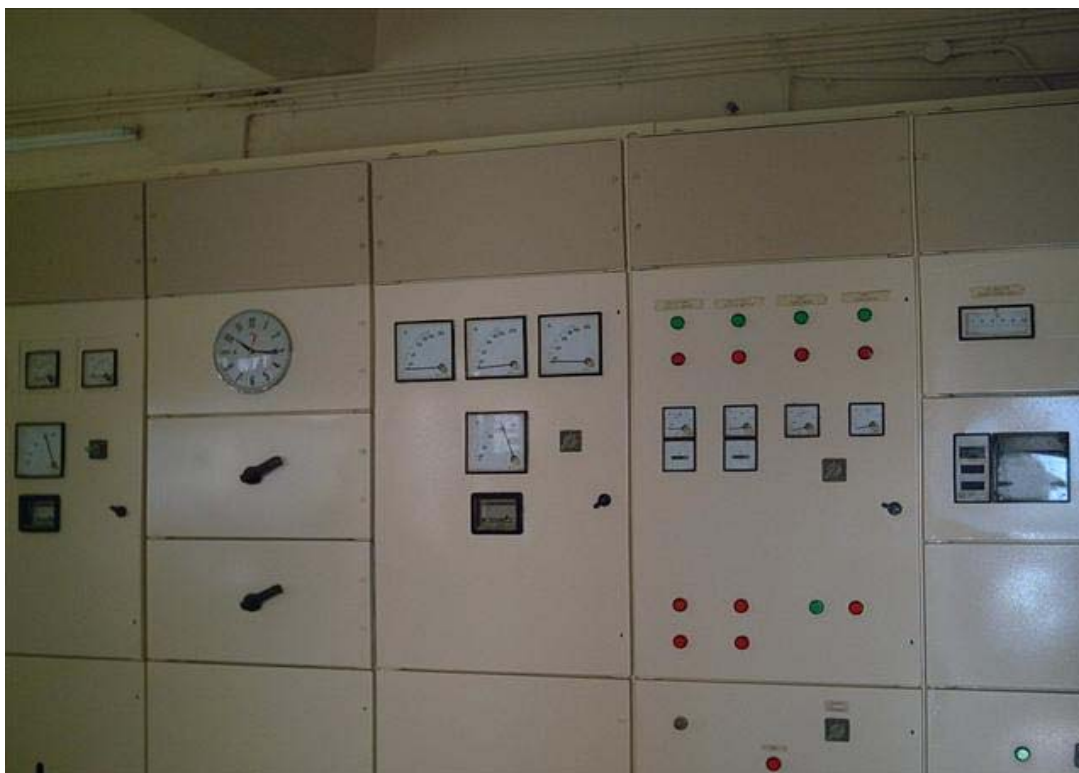
Site Photo 14 shows the pump house control panel after receiving general maintenance.

**Site Photo 14. Pump house control panel after maintenance (Photo courtesy of USACE)**

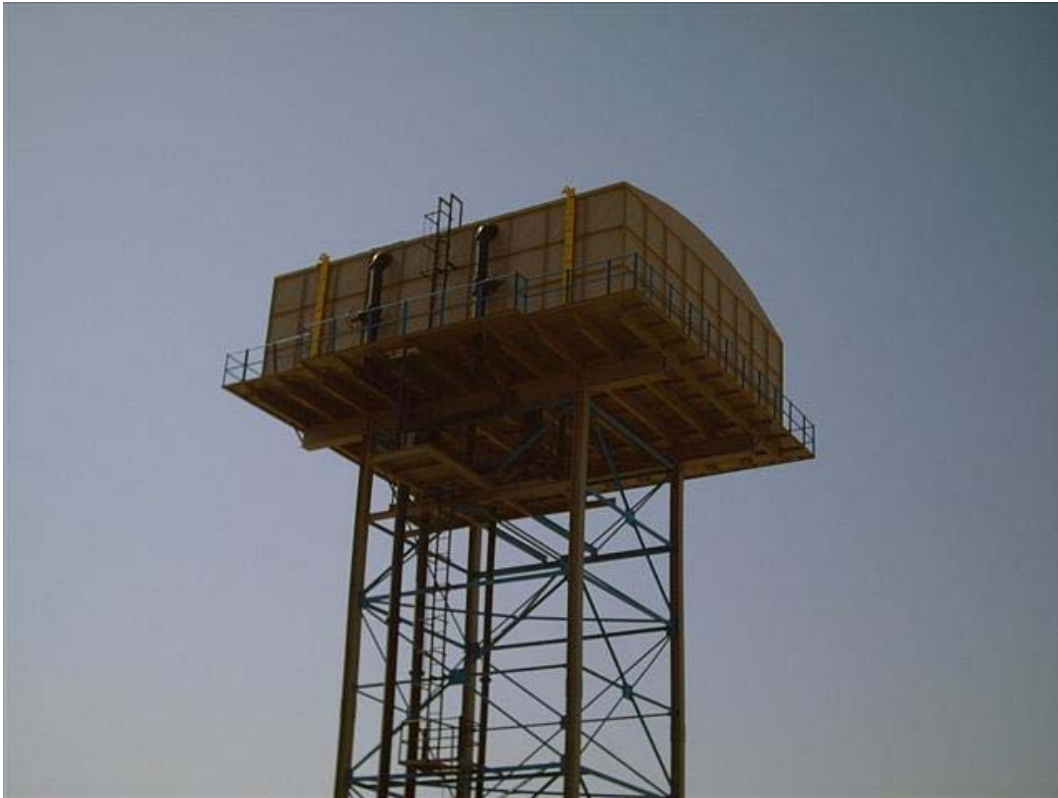
Site Photo 15 documents the elevated steel tank after receiving general maintenance.

**Site Photo 15. Elevated steel water tank after maintenance (Photo courtesy of USACE)**
